Information Report

Situation of the nuclear installations in Japan further to the major seism occurred March 11, 2011

March 24 2011 - Situation at 08h00

Fukushima I (Daiichi)

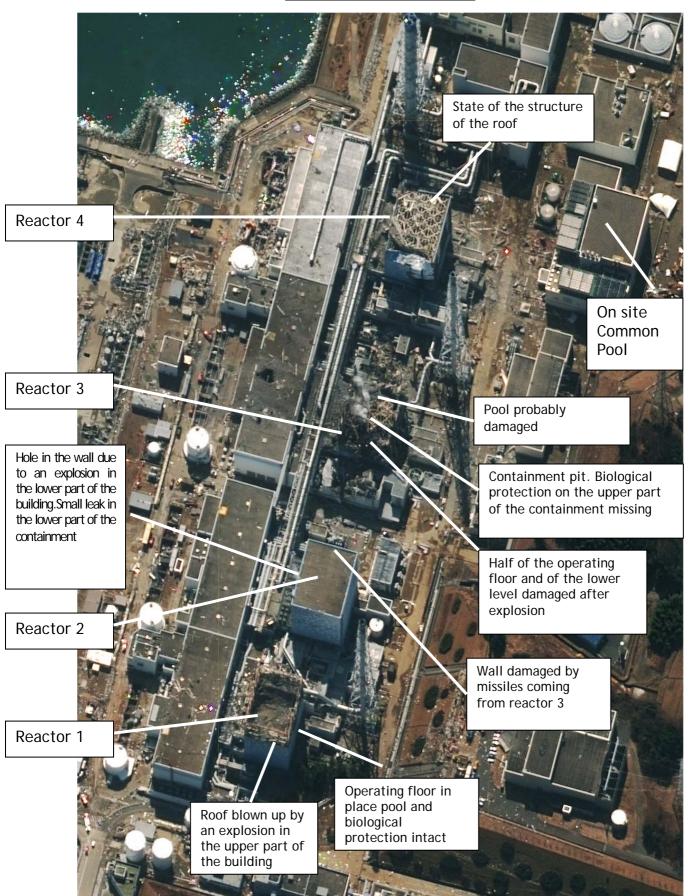
STATE OF THE BUILDINGS

The attached picture summarizes the state of the buildings on site.
